Earthworks Risk Assessment on a Heritage Railway

Martin Crapper, Michael Fell and Imad Gammoh

Accepted for publication in Proceedings of the ICE Geotechnical Engineering on 19th March 2013

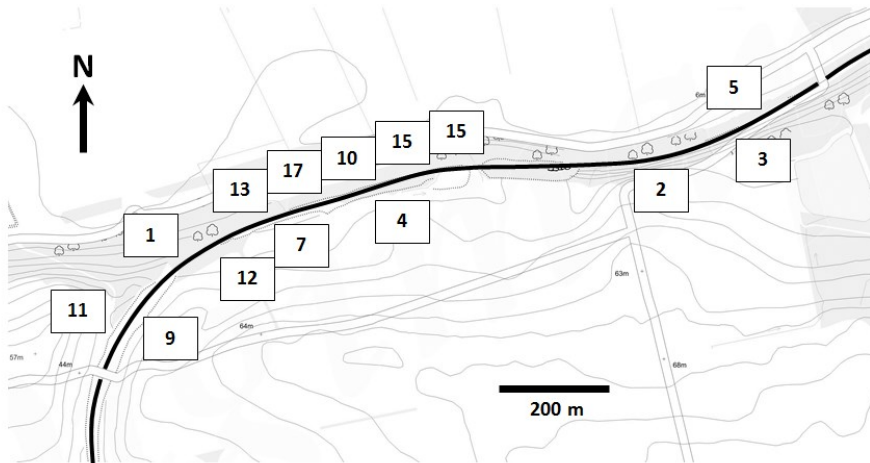
Figure 3: Earthworks Prioritization based on Network Rail weightings

In order to prioritize possible interventions on the B&KR earthworks, the prioritization toolkit was applied using all the original NR scheme unaltered. The main results of this analysis are shown in Figure 3, in which the prioritization of earthworks is indicated by the large boxed numbers, with 1 indicating the earthwork section with the highest priority for monitoring and possible intervention. Some areas have equal priority, and thus the same number appears twice; the priorities shown are not all consecutively numbered, as some of the priorities between 1 and 17 were on sections of the railway not covered by the figure.

In this result, the top priority is at a location where there has been previous disturbance due to excavation for an oil pipeline crossing in the 1980s, and the consequence includes possible impact on the pipeline. This therefore appears to make sense. However, many of the next priorities are cutting sides on the south side of the railway. Applying engineering judgement, the prioritization of these areas makes much less sense, since examination on site, together with the experience of some small past failures suggested that the cutting sides could collapse with no significant consequence to third parties, there being only woodland or agricultural land on the top side of the cutting. There is also a wide area by the line side to accommodate any debris, and if any debris did fall on the rails, the visibility for train crews was generally sufficient to achieve a controlled stop in the distance available given the 20mph maximum line speed in the area.

On the other hand, the embankment slopes given the 10th, 13th, 15th and 17th priorities had poor SSHIs and engineering judgement suggested that any failure here could have major impact on the railway. This would include undermining the track formation, severing the line and causing all income-generating operations to cease, as well as presenting a safety risk to trains and in some cases to owners of domestic property positioned below the railway.

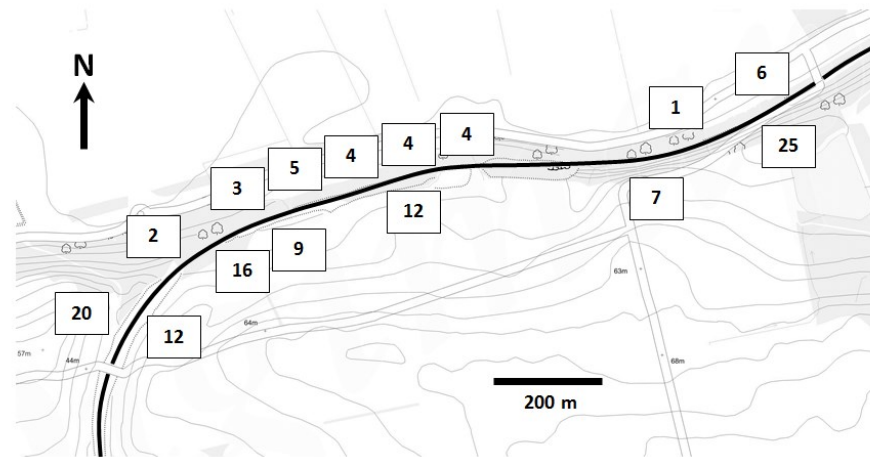
Figure 4: Earthworks prioritization based on Heritage Railway weightings

The revised priorities are indicated in Figure 4. They now tie in much more effectively with engineering judgement, the high, steep and sometimes wet embankment slopes north of the railway being given the highest priorities. If damaged, these embankments would potentially undermine the line, perhaps in a way not immediately noticeable from the driving cab of an approaching train, and they might result in collapse onto line side property. The resulting disruption would entirely remove the railway's access to an income stream either from sale of passenger tickets or revenue associated with rail tour movements for which mainline access from Bo'ness Station is required.

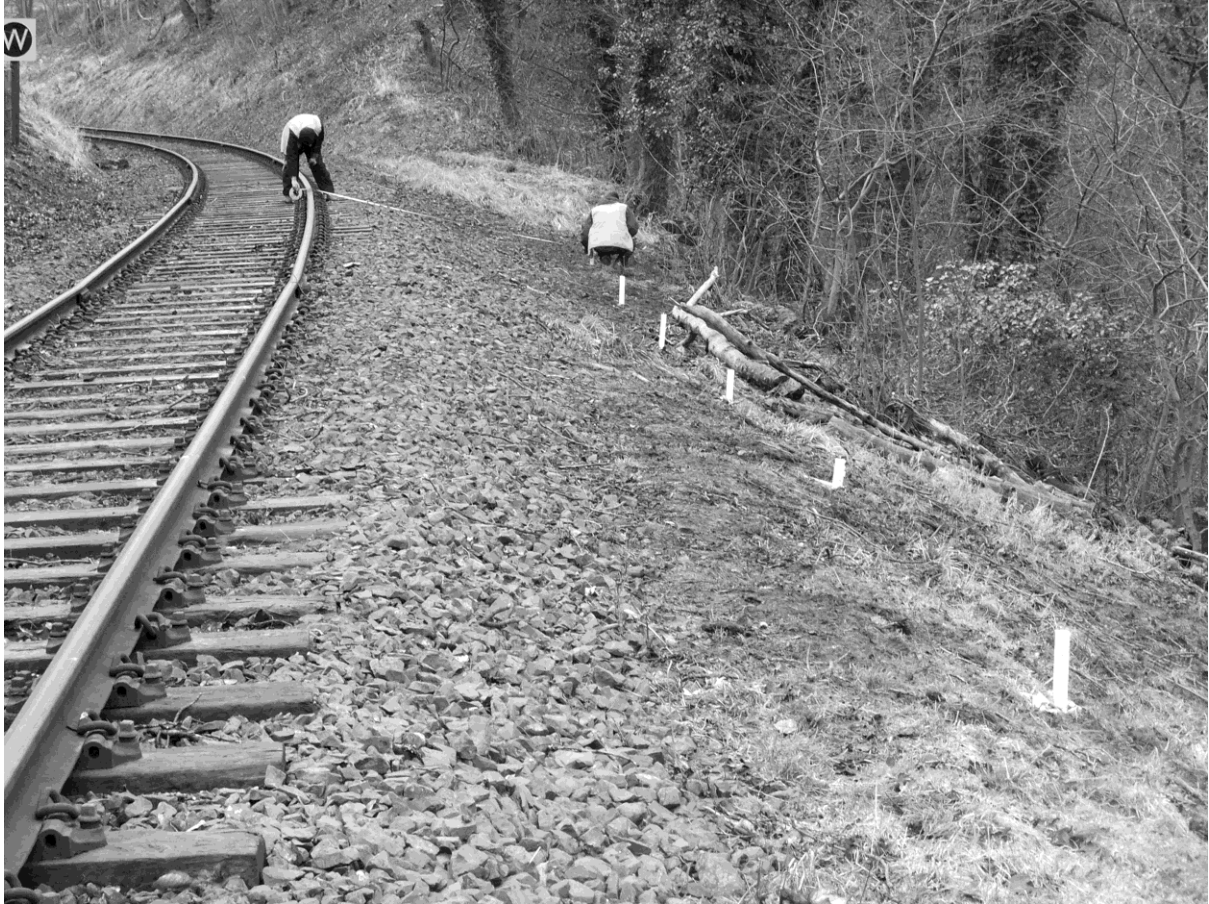
Figure 5: Setting out tell-tales in a priority area

Further, it is commonly noted that earthwork failure is rarely sudden and without warning (for example (Bonnett 2005) section 6.5, p85), and simple monitoring techniques are available to give early warning, the most obvious one being *tell-tales*, which consist of a number of pegs set out in a straight line. Any significant movement of the earthwork would result in pegs moving out of line, which would be readily observable even by an unqualified staff member. The matter could then be further investigated and potential consequences reduced. Four sets of tell-tales have therefore been placed in priority areas 1 to 4 as shown on Figure 4, and will be inspected regularly, with the distance from the running edge of the rail and track cant being monitored at each peg (Figure 5).
